MARITIME HERITAGE MINNESOTA

Phase I Archaeological Reconnaissance of the Big Island Steamboat Pier, Park, and Veterans Camp Site (21-HE-402) Project Report

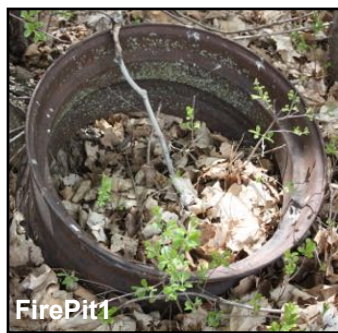
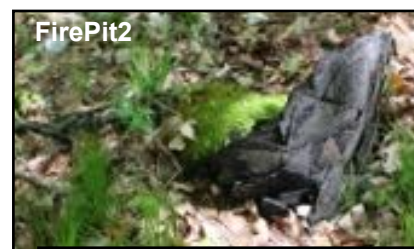
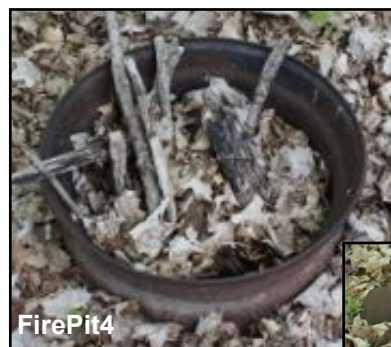
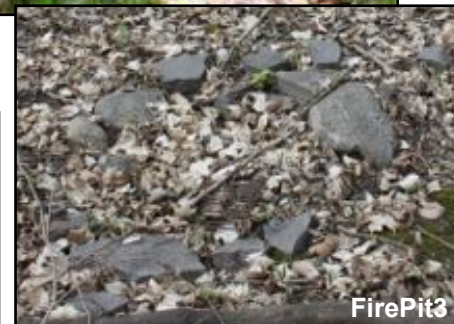
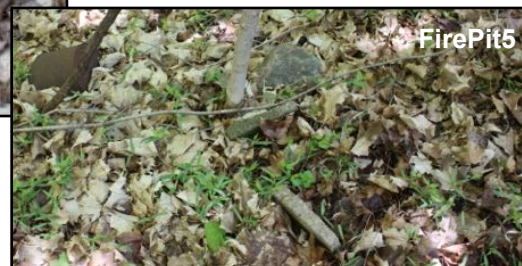
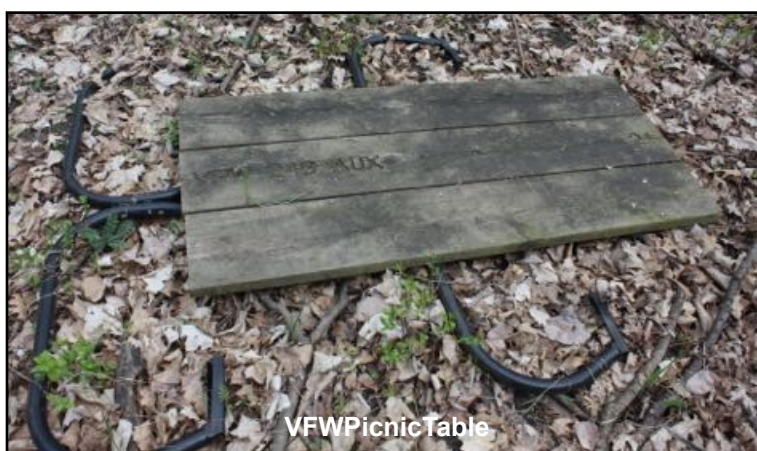
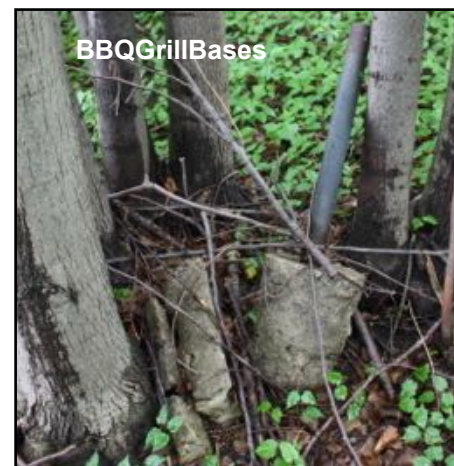
BIVC Camp Sites

In addition to the BIVC Cabins - and they lasted beyond the life of most of the cabins - several Camp Sites were offered to veterans for tent camping. The sites were numbered, were equipped with grills (some of the grill bases were re-used BIAP Lamp Bases), and picnic tables. At some point, many of the camp markers were pulled up and tossed into middens around the island, but some are still in place. MHM recorded the marked camp sites, and those without a number associated with them was given a letter designation. MHM located camp sites V3-V6, V8, V9, V24-V27 and V29, and designated others Va-Vi. MHM also identified 2 middens where the camp site signs were dumped - marked as BIVC Midden10. Lastly, MHM located 5 fire pits (FirePits1-5) that may be associated with camp sites, BBQGrillBases, and 1 PicnicTable marked as belonging to the VFW.

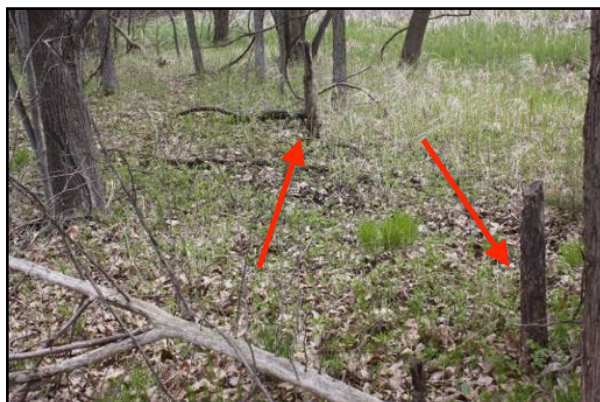
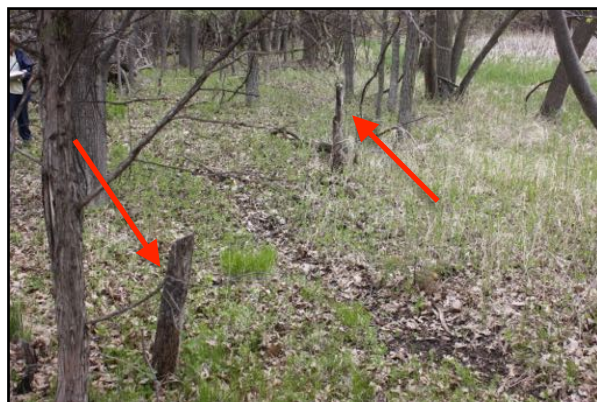
BIAP Zoo

The BIAP had a small Zoo for a time (Maravelas Chapter 10). MHM located some old fence posts near the western edge of the project area that may be remnants of the animal enclosures. However, the Zoo could have moved around the island as needed, so this identification is tentative, and the fence posts could be linked to the Game Farm.

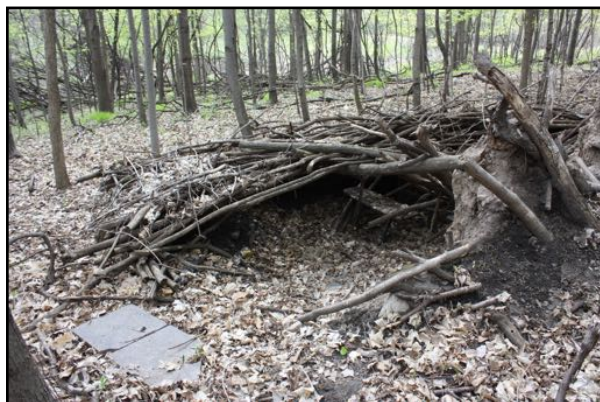
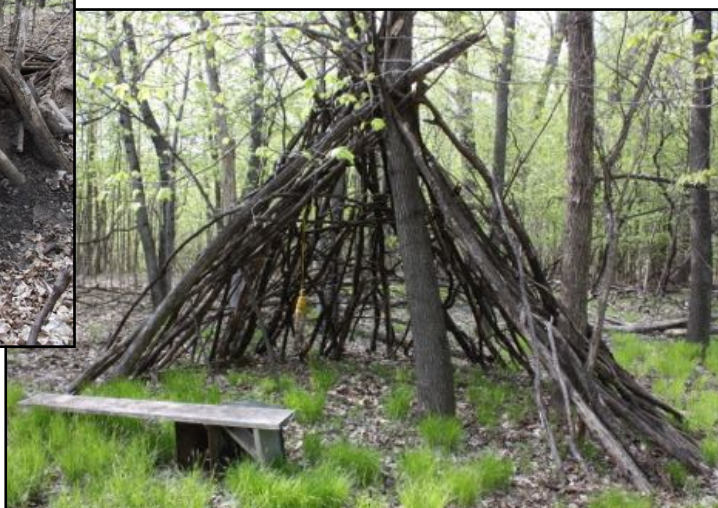
Beyond the 'garbage'¹⁶ strewn all over the project area, a modern septic system was installed at some point in the last 10 years or so. As far as MHM can ascertain, no major damage was inflicted on archaeological features; although, a modern pipe was laid down directly through 1 of the Pergola's column bases. Further, 3 modern 'Tree Shelters' are found in different parts of the project area. These invasive structures should be dismantled because they are not entirely harmless; whomever is making them is moving around artifacts, mostly from the BIVC Cabin and artifact middens. These actions are illegal and they must cease.

Two 'Modern Tree Shelters' whose construction disturbed archaeological features and artifacts.

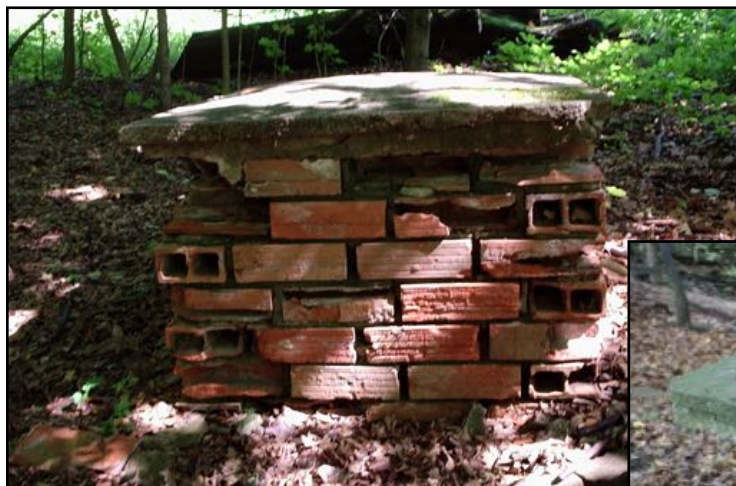
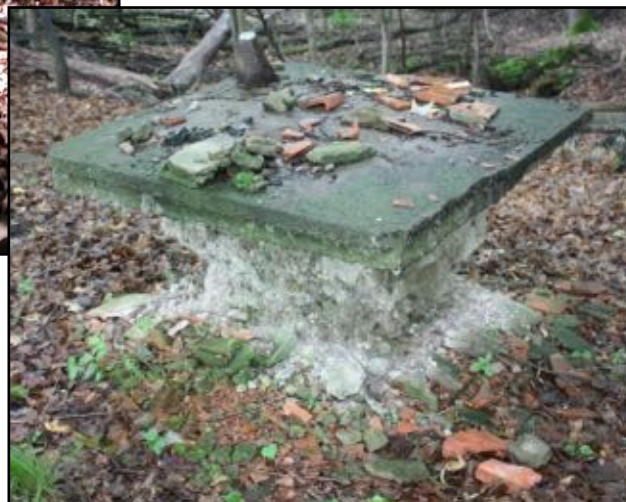
Now that MHM has confirmed the existence of nearly major construction associated with the BIAP, any future considerations concerning walking path placement, facilities construction, forest management - any activity that might threaten protected archaeological features - must take them into account. Further, the stabilization of archaeological features and artifacts is paramount to the continued survival of these finite cultural resources. Of particular concern is the Archways Wall (A7); it has deteriorated since 2007. Also, the near-destruction of the Plinth near A7 is a criminal act; this type of activity must be stopped in the future.

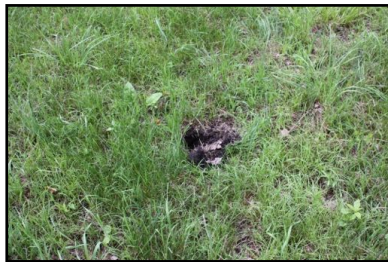
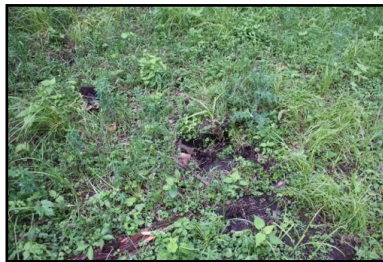
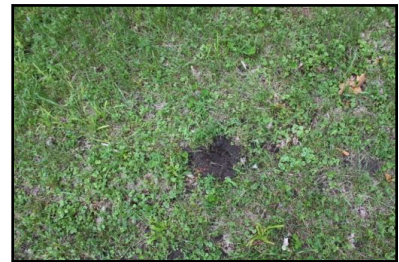
Looter's Holes 2019

While MHM was conducting fieldwork on the island, 2 men were found to be looting artifacts and disturbing the archaeological site using shovels and metal detectors. MHM approached the men to explain that their actions were illegal; they disagreed, and MHM called the Hennepin County Sheriff's Water Patrol. Just these 2 men with shovels disturbed a significant amount of the site - and MHM has no way to know what artifacts were taken or what features were disturbed.

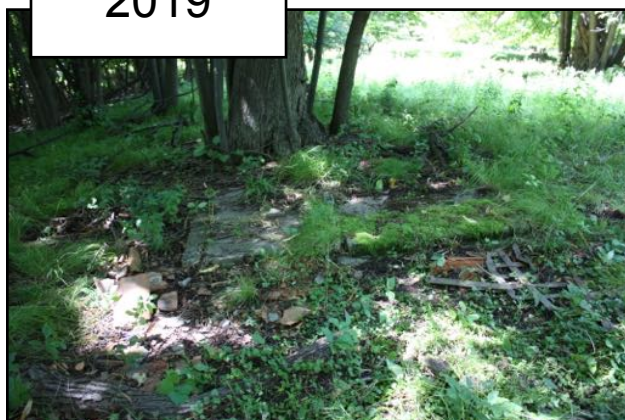
The only archaeological evidence of C12 that survived in 2007 was a re-used BIAP step. This step had been moved by 2019 and is part of Feature TP Midden below.
